CSB Safety Bulletin

U.S. Chemical Safety and Hazard Investigation Board

Dangers of Purging Gas Piping into Buildings

No. 2009-12-I-NC

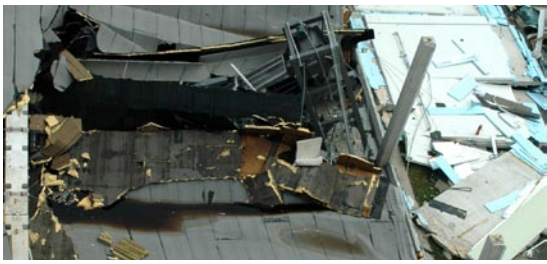
The ConAgra Slim Jim plant in Garner, North Carolina, where unsafe gas purging caused an explosion in June 2009 that killed three workers and sent 71 to the hospital.
